ENGINEERING REPAIR REPORT

SHIH WEI-CHIEH – “I AM VERY HAPPY I HOPE YOU ARE TOO” HEADDRESS ARTEFACTS

PREPARED BY ALBERT ONG

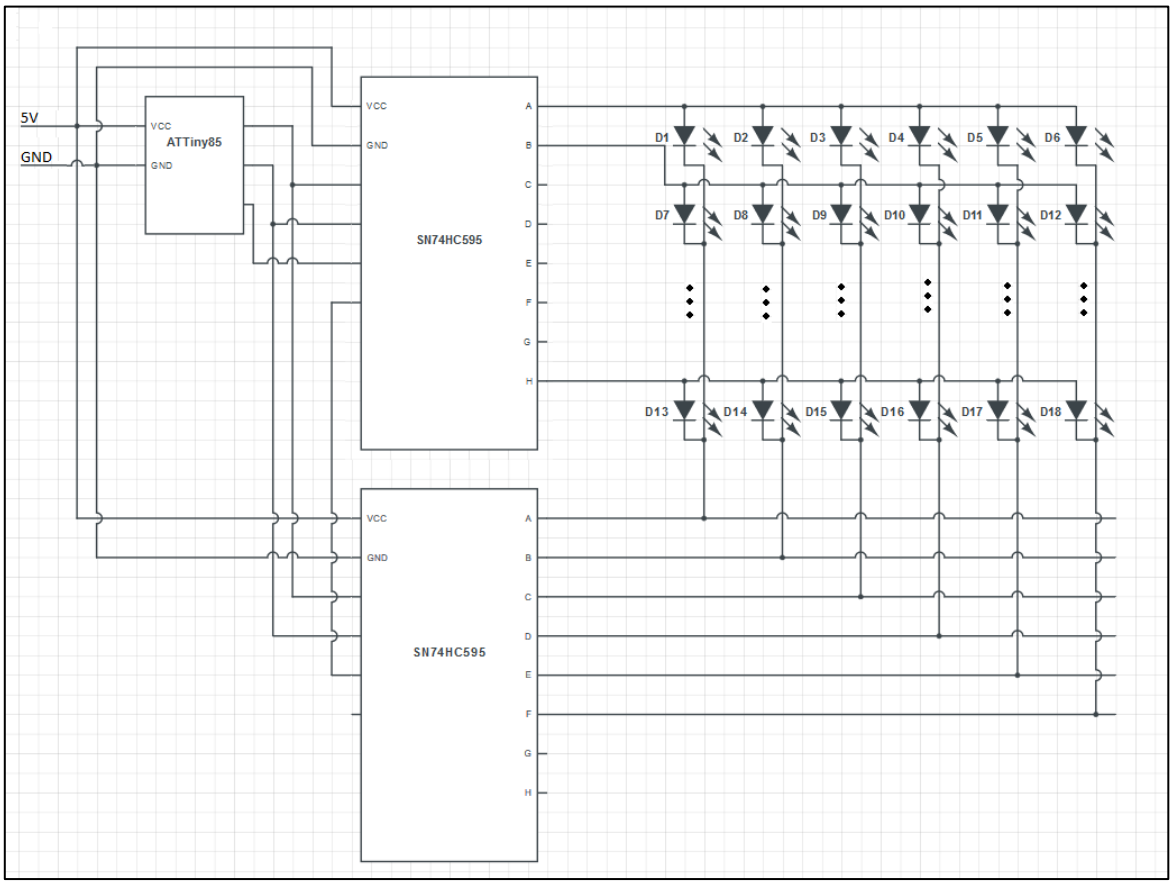
Figure 1 - High level schematic demonstrating bus lines and general LED Matrix Circuit.

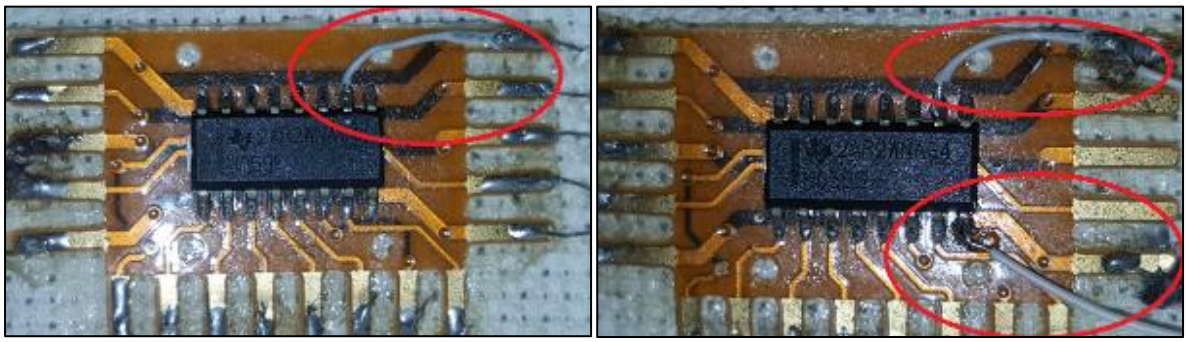
Upon visible inspection, we identified no visible damage to ICs (based on physical damage, burns or corrosion), and no cold solder joints were observed. However, jumper wires were observed (see Figure 2) to be soldered between components, film circuit boards and printed circuit boards, suggesting previous repairs/modifications were performed to address problems with electrical discontinuity (broken wires in the circuit) by acting as redundant/replacement connections.

Figure 2 – Two different shift Register ICs mounted on film circuit boards. Note jumper wires (white wires circled in red) not originally part of the existing film circuit boards are soldered.

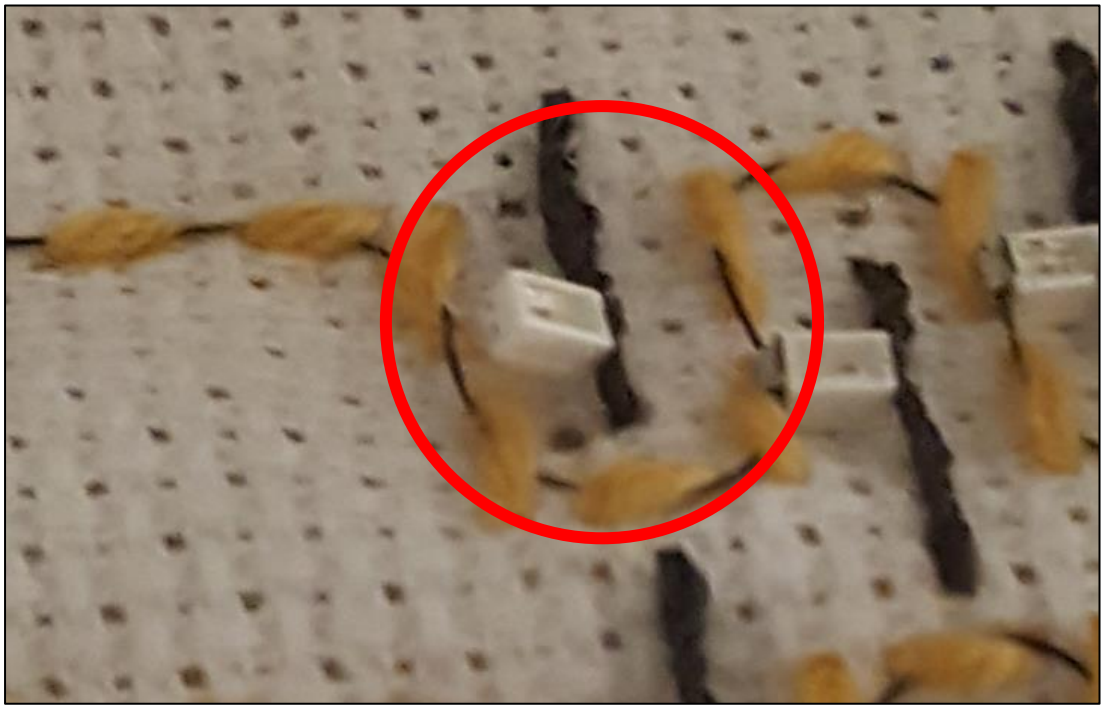
Further inspection of the LEDs uncovered a number of LEDs with damaged or missing legs (see Figure 3). The missing leg(s) render the LED non-functional and will require replacement of the LED.

Figure 3 - LED with damaged/missing clip leg requiring replacement (circled in red).

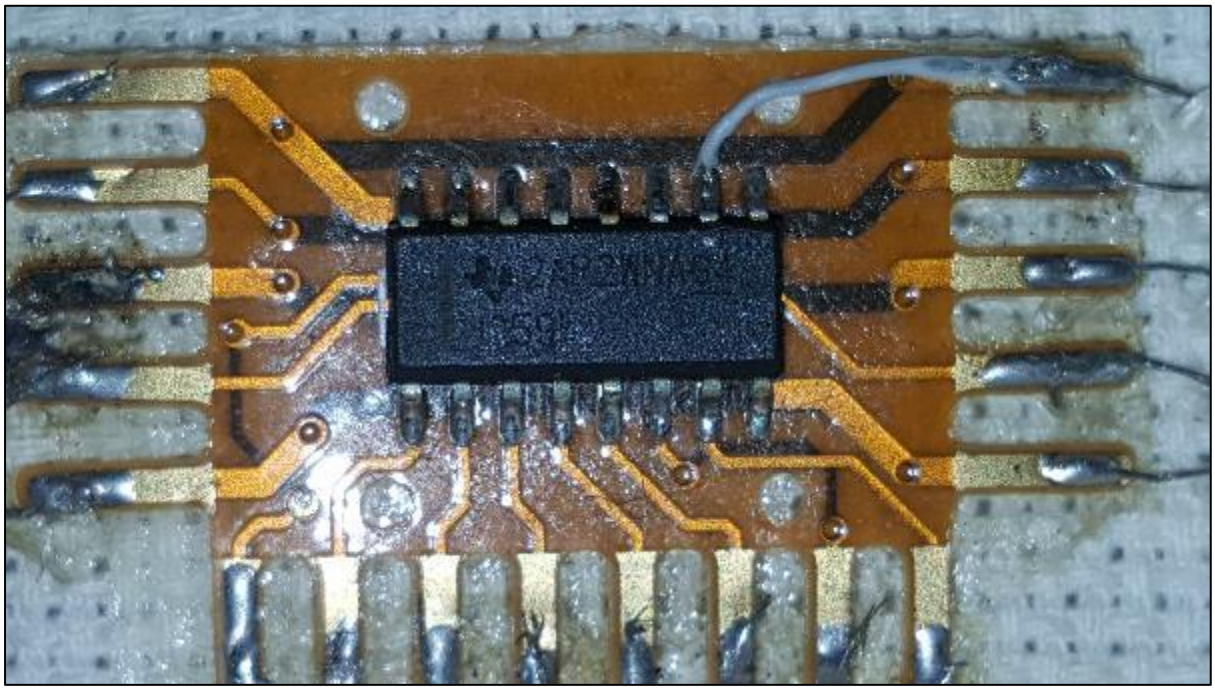
Regarding ICs installation methods used, SN74HC595 Shift Register ICs were surface mount soldered to film circuit boards. These were then subsequently glued to the fabric (see Figure 4).

Figure 4 - SN74HC595 Shift Register IC mounted to film circuit board, which is glued to fabric.

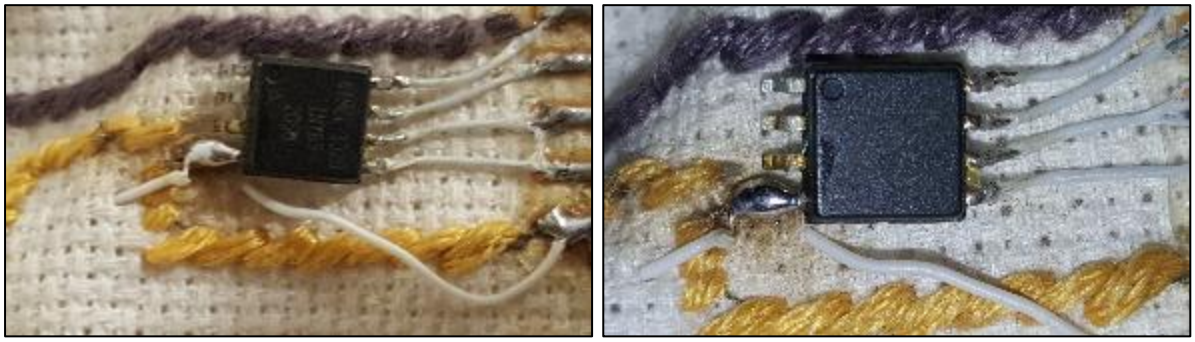
ATTiny85 microcontroller ICs were soldered to film circuit board pads with jumper wire extensions (see Figure 5) from the IC legs. However, the ATTiny85 ICs themselves were not adhered to the fabric in any way, posing a risk of damage from mechanical stresses/vibration. Further, because ATTiny85 microcontroller ICs were hand soldered to the jumper leads, the size of the solder joint is typically inconsistent, and large joints (see Figure 5 (right)) risks electrical shorting with adjacent legs.

Figure 5 - ATTiny85 microcontrollers connected to SN74HC595 film circuit board using jumper wires to extend legs (left). Large solder joint (right) risks an electrical short to adjacent leg (which should not be electrical connected).

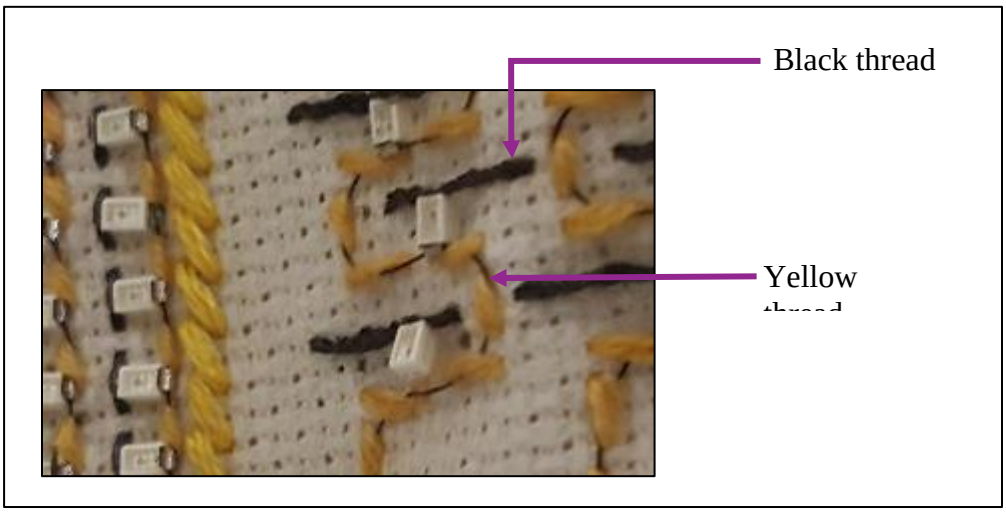
Copper traces/tracks were not used to establish electrical connections between boards (both film or rigid) and LEDs in the circuit. Instead, two types of '*thread wire'* were used to assemble the circuit (see Figure 6):

Resistance of both yellow/purple thread and black thread was also measured – testing across a length of thread length of approximately 200mm yielded a resistance of approximately:

- **Yellow/purple thread**: 15Ω / ~200mm, and
- **Black thread**: 100Ω/ ~200mm.

Figure 6 – Types of thread used to connect circuit boards and LEDs. Note the metal thread passing through the yellow thread, but not through the black thread.

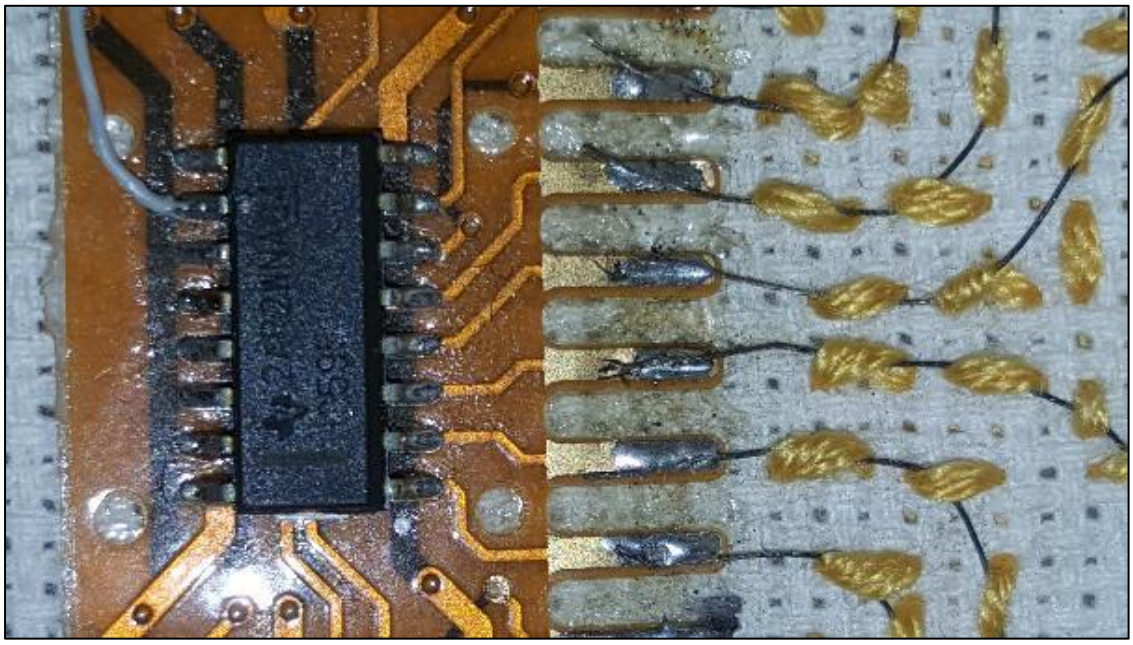
Figure 7 - Connection of thread to film circuit board

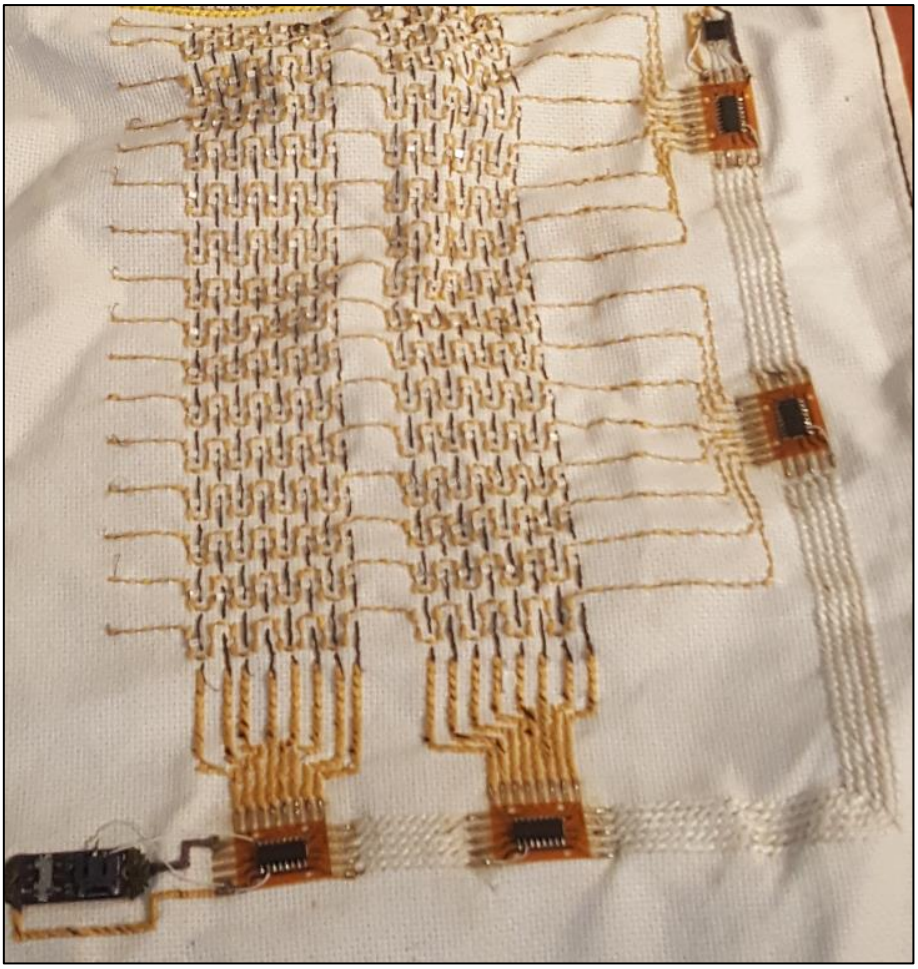
Figure 8 - Thread connections between film circuit boards, rigid circuit board (power supply connector), and LEDs

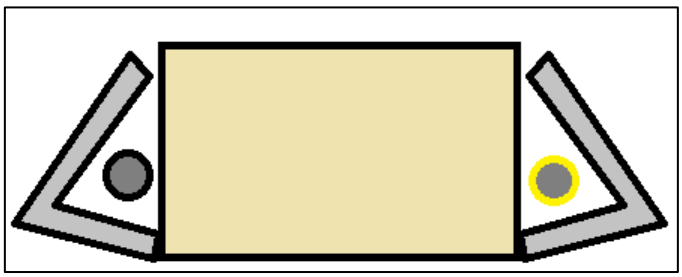
From observing with a magnifying glass, there was a clear gap between the LED wing legs/clips and the conductive wire. This is illustrated in Figure 9. This air gap demonstrates that the crimps do not bite down onto the thread, and thus cannot establish nor maintain electrical connection.

Figure 9 - Illustration of LED with wing legs/clips, and thread wires. Note that the crimps do not 'bite' onto the wire, and because of this, electrical connection is not maintained, resulting with non-illuminating LEDs

An alternate option was to crimp the legs together to maintain contact by squeezing the contacts into the LED. Doing this makes the LED contacts "bite" into the thread, and this ensures electrical connection with the black/yellow thread wires. However, due to the brittle nature of the LED wing crimps, a small number of these snapped off entirely, rendering these particular LEDs non-functional; these LEDs require replacement.

5.1. USE MEASURES TO CRIMP OR MAINTAIN CONTACT BETWEEN LEDS AND THREAD WIRE

- Crimping LED contacts to 'bite' onto the thread wire – this mechanically ensures electrical connectivity, but there is a risk of snapping the LED contacts in the process,
- Applying solder, or some form of conductive adhesive, between LED contacts and thread wires – this fills any gaps, but risks affecting the appearance of the artefacts,
- Tying the thread wire around each LED contact tightly to ensure connection – given the large number of LEDs, this approach is laborious, and mechanical vibration or changes in the environment can cause the thread wire loops around the LED contacts to loosen over time.
- Selection of an alternative model of LED which accommodates for any of the above points.

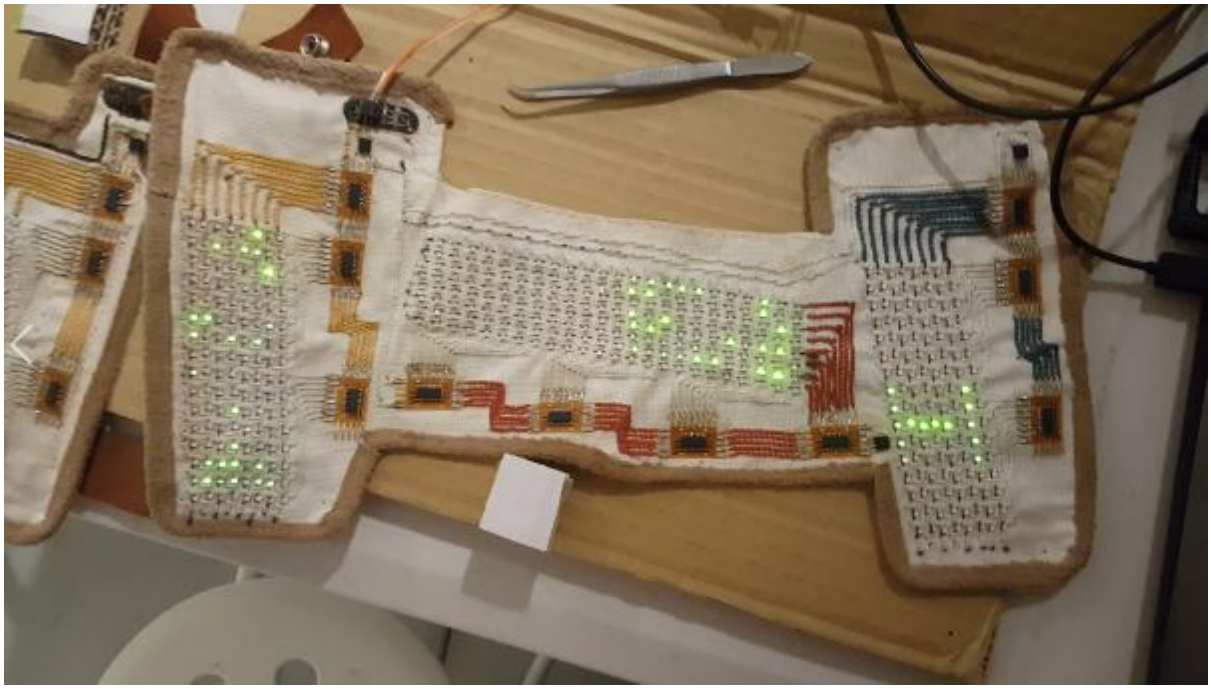
Figure 10 LED sections appeared after crimping the LED wings. This allows the LED to 'bite' onto the conductive thread wires, and establish electrical connection.

Once LED legs were crimped for entire sections, scrolling text then began to appear as shown in Figure 10.

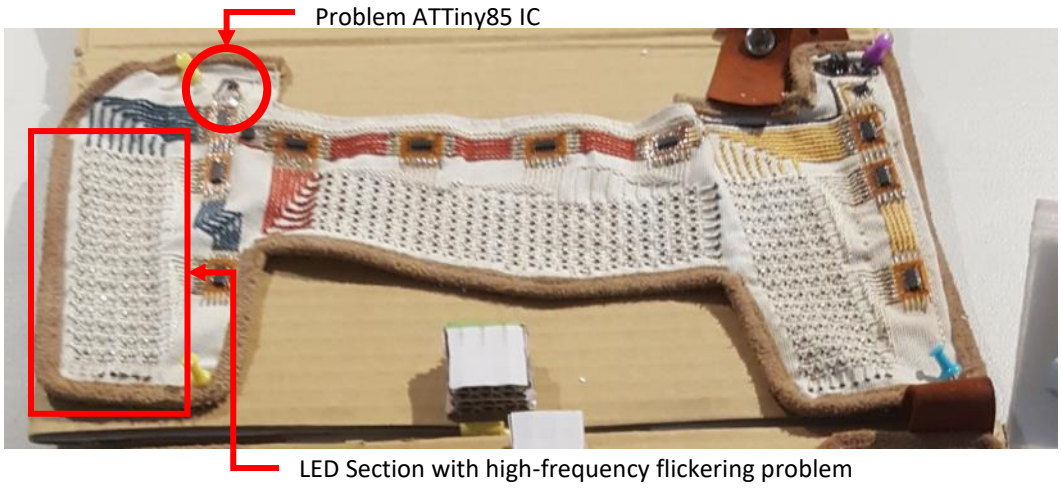
On one section of LEDs on one of the wings, the entire section was found to be continuously flickering at a high frequency (identified once LED wings were crimped and LED functionality was restored). We suspected that there was corruption in the ATTiny85 microcontroller, which controls this section of LEDs.

Figure 12 - LED Section with high-frequency flickering problem, suspected to be due to a corrupted/damaged ATTiny85 microcontroller

Due to the short time-frame, and not having the available source code, flashing equipment and a spare ATTiny85 IC at the time of repair, we were unable to perform the repair on this section of the artefact. We have left this as a recommendation for future repair.

In order to restore scrolling text in the LED section highlighted in Section 4.4, the ATTiny85 microcontroller IC needs to be re-flashed, or replaced and re-flashed with source code.

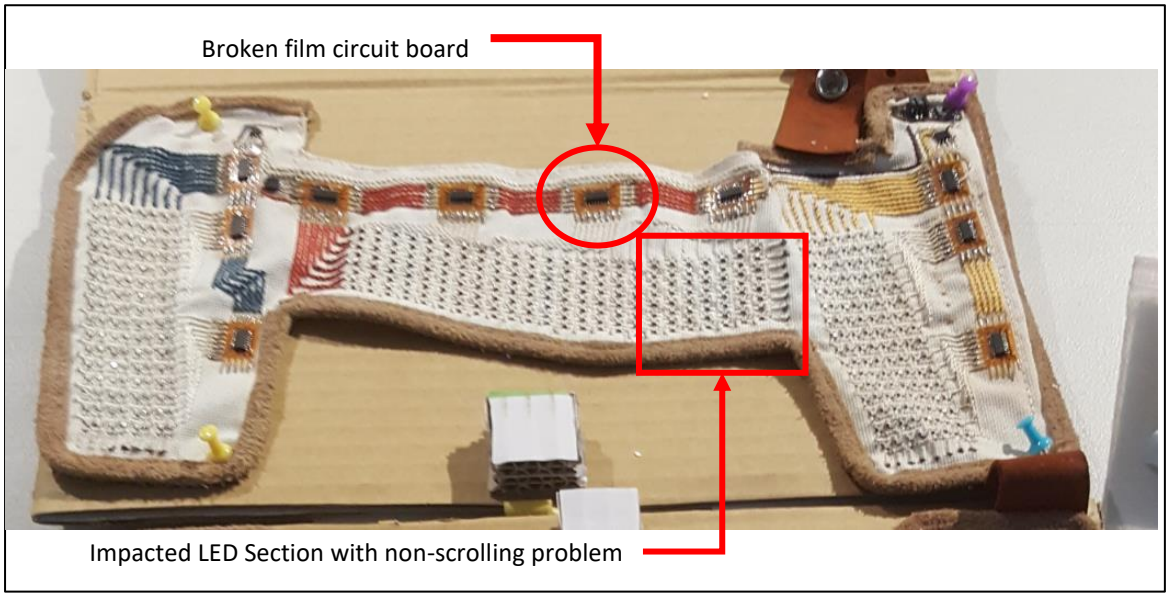
On the same artefact in Section 4.4, an electrical discontinuity was identified on one of the film circuit boards. This film circuit board (highlighted in Figure 13) has discontinuity between the mounted SN74HC595 Shift Register IC pin and film circuit board pad (highlighted in Figure 14). This particular pad is required for passing communications to the next SN74HC595 Shift Register IC in the chain, and affects the LED cluster (highlighted in Figure 13) by preventing text scrolling in the LED cluster (because no new communication can be sent to the SN74HC595 Shift Register IC controlling the LED cluster).

Figure 13 - Location and affected LED section from broken film circuit board.

Due to the hardware issues of the artefact, we advised that this particular wing cannot be functional during showcase. The other wing (with restored functionality) could be presented powered for short periods, and continuous operation was not advised due to the absence of current limitation, and this posed a risk to overstressing the SN74HC595 Shift Register ICs.

In order to restore scrolling text in the LED section highlighted in Section 0, the film circuit board for the particular IC needs to be replaced.

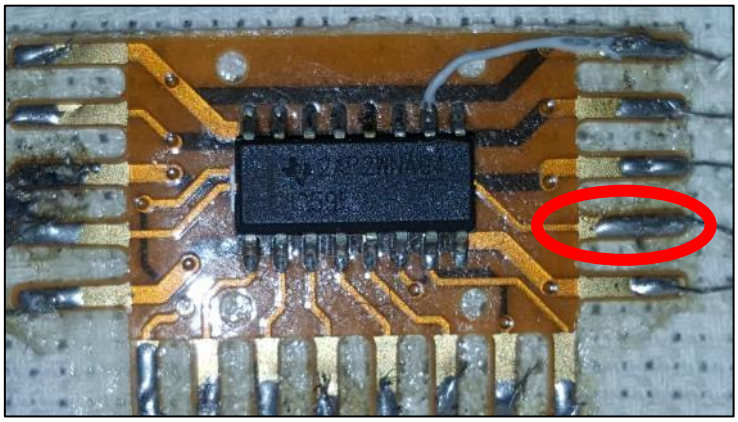
Figure 14 - pin affected by broken film circuit board, caused by either a broken IC pad, trace, or board via.
